Three-phase transformer arcing horns; neglected deadly components to birds

Abstract – Unprotected power transformers are known to create electrocution problems for wildlife. However, the role of three-phase transformer arcing horns and bird electrocutions has not been investigated. Arcing horns are rigid conductors sometimes deployed to protect insulators by providing a gap for lightning to jump across without damaging the equipment. To identify how birds are electrocuted by arcing horns we submitted a survey to 32 Iranian utility companies and examined 562 opportunistic utility outage records of bird electrocutions between 2018 to 2019. We documented 59 electrocuted birds and classified five types of arcing horn electrocutions based on where the carcasses were discovered. To mitigate such problems utilities sometimes remove arcing horns but doing so can be problematic to the power network. Using insulation is not entirely effective because the point of the upper rod can produce an electrical discharge to the head of a bird perching on the lower grounded rod. We provide alternative solutions.

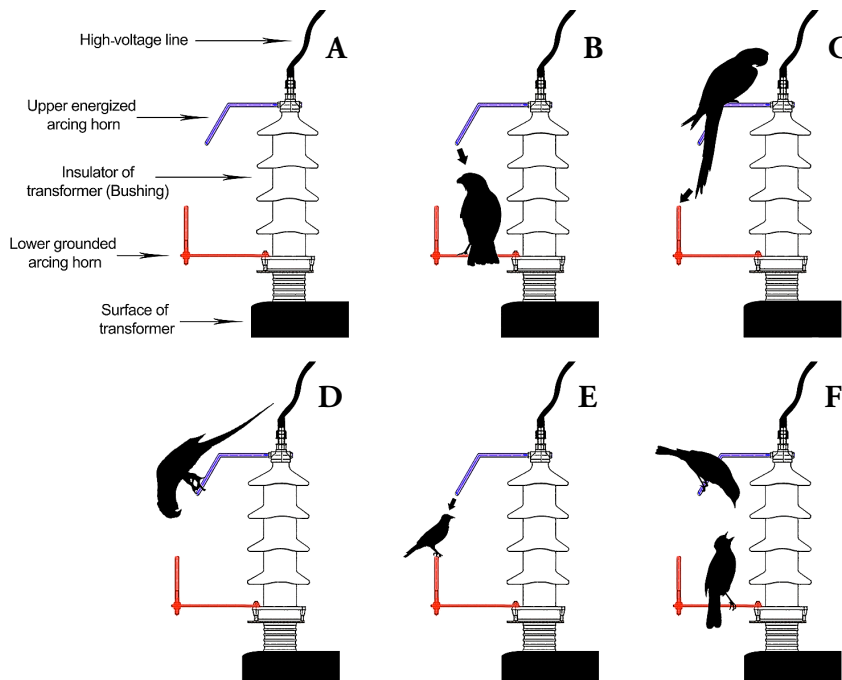
We classified five types of incidents related to where each carcass was found in relation to the arcing horns (Fig. 1) (*see* Table 1, Type 1 through Type 5). Type 1 consisted of birds perched on the lower –grounded– arcing horn’s horizontal support (36 incidents with 40 birds affected), subsequently bridging the gap to the upper energized arcing horns, resulting in a phase to ground electrocution. Raptors including the Common Kestrel *Falco tinnunculus* and Eurasian Sparrowhawk *Accipiter nisus* were involved in this type of incident (Fig. 1B). Type 2 included only long-tailed birds (e.g. Rose-ringed Parakeet *Psittacula krameri* and Eurasian Magpie *Pica pica*) perched on upper energized arcing horns (3 incidents with 3 carcasses), then bridging the gap to the grounded lower arcing horns with their long tails (Fig. 1C). Type 3 occurred when Psittaculidae species climbed from one arcing horn rod to the other rod (4 incidents with 4 carcasses), making simultaneous contact between the energized and grounded parts (Fig. 1D). Type 4 was similar to the first type, but occurred when small birds such as a House Sparrow *Passer domesticus* or Common Starling *Sturnus vulgaris* perched on the

tip of the lower grounded arcing rod (9 incidents with 9 carcasses) then touched their head into the upper energized arcing horn (Fig. 1E). Type 5 was assigned when multiple small birds were electrocuted (1 incident with 3 carcasses). In this situation three small birds (belonging to the lark family, Alaudidae) perching on both upper and lower

horns, subsequently interacted with each other and filled the void between the grounded and energized arcing horns (Fig. 1F). Note, this differed from one other multiple incident which occurred when three Eurasian Magpies were killed on a single transformer, but on three different arcing horns (classified as Type 1).

Figure 1. Types of bird electrocution incidents by arcing horns; (A) Medium-voltage transformer bushing and its arcing horns; (B) Proximity of the bird's head to energized horn and occurrence of an electrical arc from the horn to the bird's head, defined as Type 1; (C) Proximity of the bird's tail to lower horn and occurrence of an electrical arc between them, defined as Type 2; (D) Situation when a parrot comes down from upper horn to lower one, defined as Type 3; (E) Situation when a small bird sits on the peak of the vertical rod of the lower horn, defined as Type 4; (F) Situation when multiple birds interact on arcing horns, defined as Type 5.

In this study, 75% of the birds (n=59) were electrocuted while perching on the lower horizontal ground rod (Fig. 1B). Therefore, a method to be considered is insulating the lower grounded rod. This simple approach would allow birds to perch on the horizontal rod without allowing a pathway to earth (Fig. 2G). Isolating the ground plane is an approach sometimes used in electrical substations to prevent animal contacts on difficult to cover equipment such as switches (EPRI 2016). The upper rod could also be covered for additional protection. This approach could be taken with solid insulating hose, split seam insulating hose, fusing tape, or shrink wrap. Moreover, it may represent a cost-effective solution however it needs to be tested to ensure the insulation would not affect arcing performance and that insulating materials would withstand electrical stresses. Note, if the insulation is not extended beyond the rod tips, it would still not be effective for the remaining contact types. Another approach would be to build a cover to encase the entire gap.

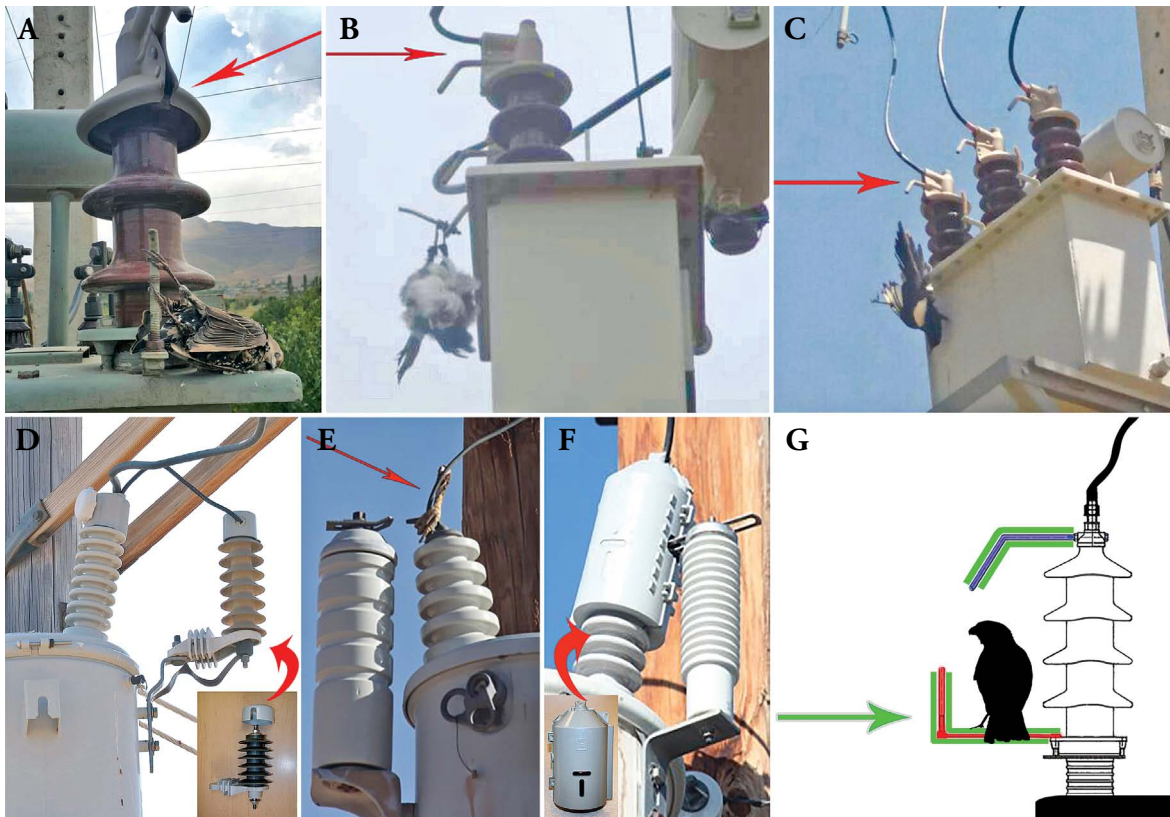
Arcing horns can kill any bird or animal large enough to span the horn gap. The records we reviewed included birds as small as House Sparrows and as large as a Sparrowhawk. Although all the birds were species of Lesser Concern, sensitive species would also be at risk, thus relevant for bird conservation. According to the survey results, 11 out of 32 Iranian power companies (34%) voluntarily avoid using arcing horns in new transformer installations to mitigate possible animal incidents. However, this practice leaves transformers unprotected against overvoltage, therefore this measure is not preferred from an engineering standpoint. Conversely, a more common approach adopted by 66% of power companies is insulating transformer bushings with covers which only partially shield the upper arcing horns. This corrective measure was typically employed during transformer installation. Covering the horns in this fashion can decrease the likelihood of some bird electrocutions, but even with insulation the arcing horns are still exposed and electrical discharges from the upper energized horns to birds perching on the lower rods can still occur. Several birds in our review were electrocuted under this scenario (n=14: containing 9 and 5 incidents related to first and fourth defined types, respectively) (Figs. 2A, 2B and 2C).

Figure 2. Neutralizing lightning arresters threats to birds: (A,B,C) Bird electrocutions by arcing horns despite using insulating materials on bushings and upper energized rods (note red arrows show insulating materials). (D) Surge arresters can be mounted on transformer tanks to eliminate the need for arcing horns. Note, each surge arrester should be installed with a protective cap and an insulated jumper. (E) Older type gapped surge arrester mounted on a transformer tank. Note bird foot attached to the top of the unprotected transformer bushing. (F) Transformer bushing cover designed with knockout plates to accommodate a gapped arrester strike plate, either horizontal or vertical (colored black), installed on a gapped surge arrester, making it animal friendly. Note, the transformer bushing also has an insulated jumper. (G) Grounded arcing horn covered with tubular insulation to isolate the ground, allowing birds to safely perch on the horizontal insulated rod.

In new construction, transformers can be ordered with internal surge arresters, making the need for external arcing horns unnecessary (NRECA 1996). Another alternative is to use tank mounted surge arresters instead of using arcing horns. When potentially dangerous surges occur, a surge arrester activates and diverts lightning to ground (without a gap), where it disperses harmlessly. Such surge arresters

do not have an arcing gap and are more reliable, plus come with protective animal caps (Fig. 2D).

In the United States gapped surge arresters (Fig. 2E) are used on some electrical systems, creating similar outage problems (NRECA 1996). To address the challenge of protecting birds and mammals in North America from bridging the arcing gap, specialized bushing covers are available (EPRI 2019). These bushing covers have a knockout designed to accommodate the grounded arrester strike plate while isolating the energized bushing top (Fig. 2F).
